## City of Colusa Submission

### Information needed to characterize individual Ag Dominated Water Bodies

## Appendix A – Photos of Colusa Subarea Water Bodies

## Appendix B – Flow-related Photos in Colusa Subarea Water Bodies

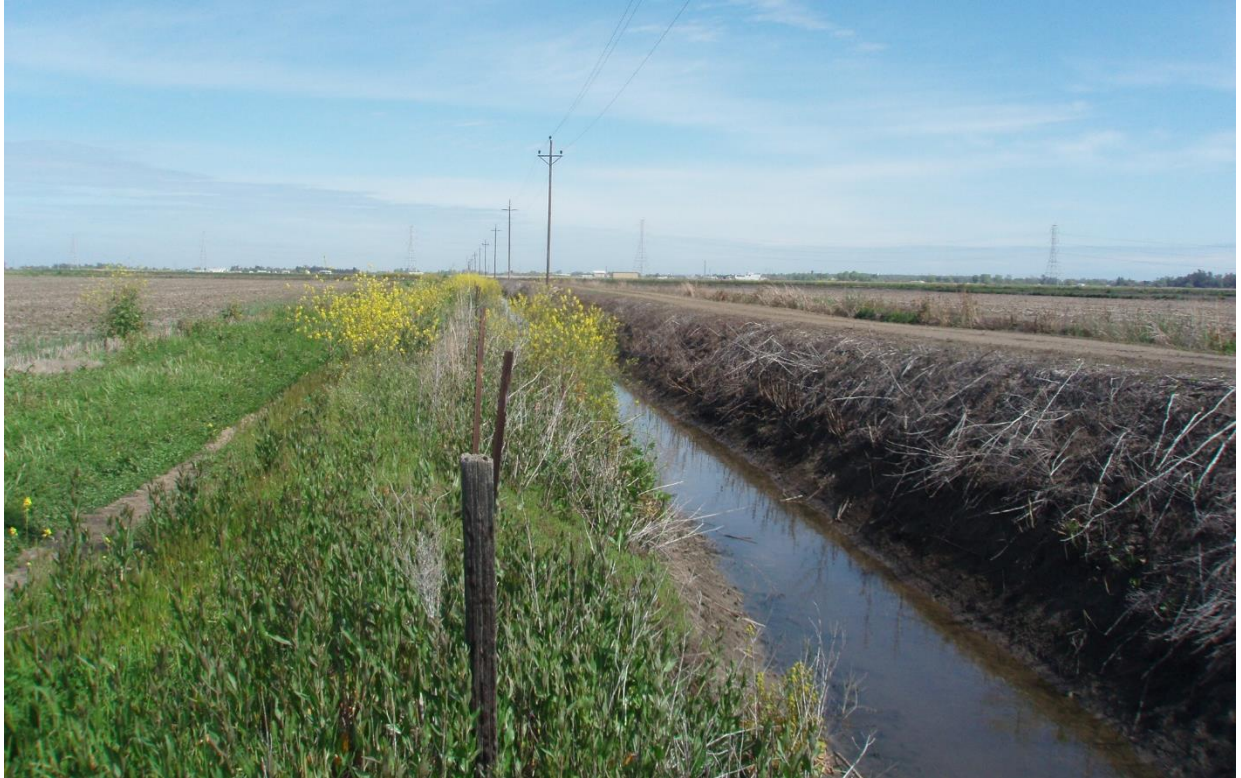
Photo 1. Unnamed Tributary to Powell Slough, downstream of effluent discharge (looking upstream) – April 16, 2012

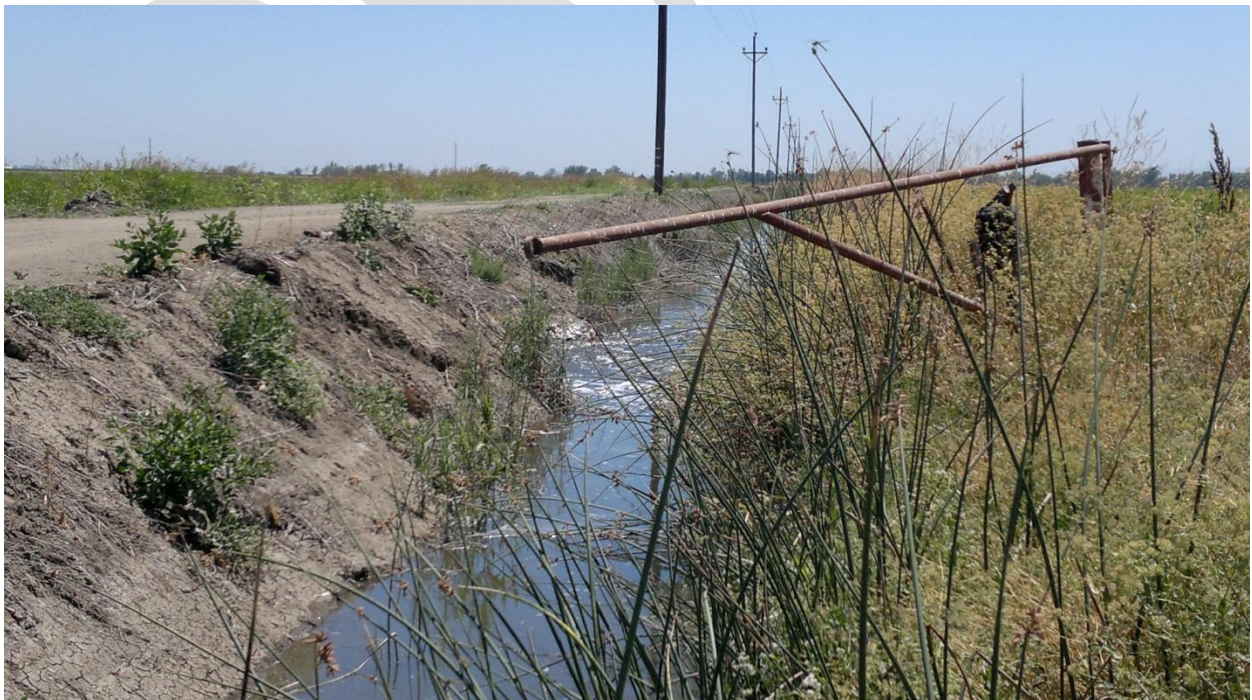
Photo 2. New Ditch (2011) upstream of effluent discharge (looking downstream) – June 28, 2012

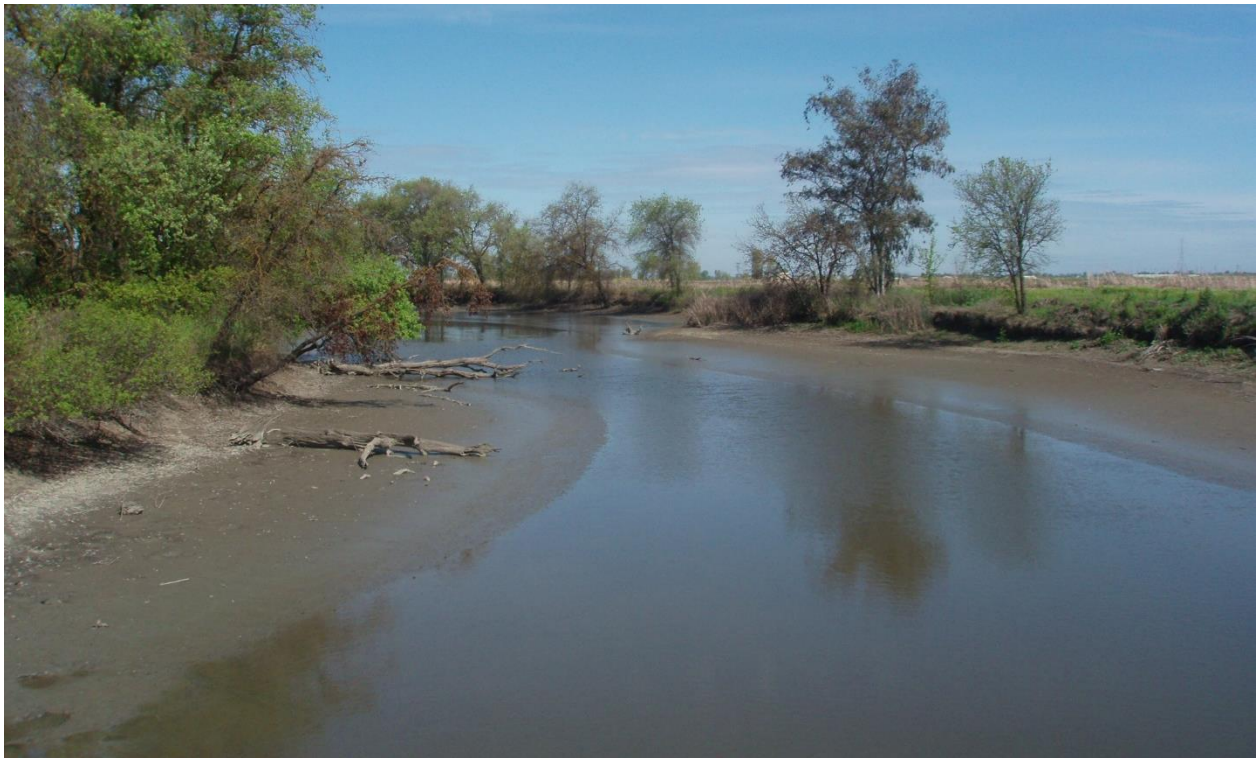
Photo 3. Powell Slough upstream of Unnamed Tributary confluence (looking upstream) – April 16, 2012

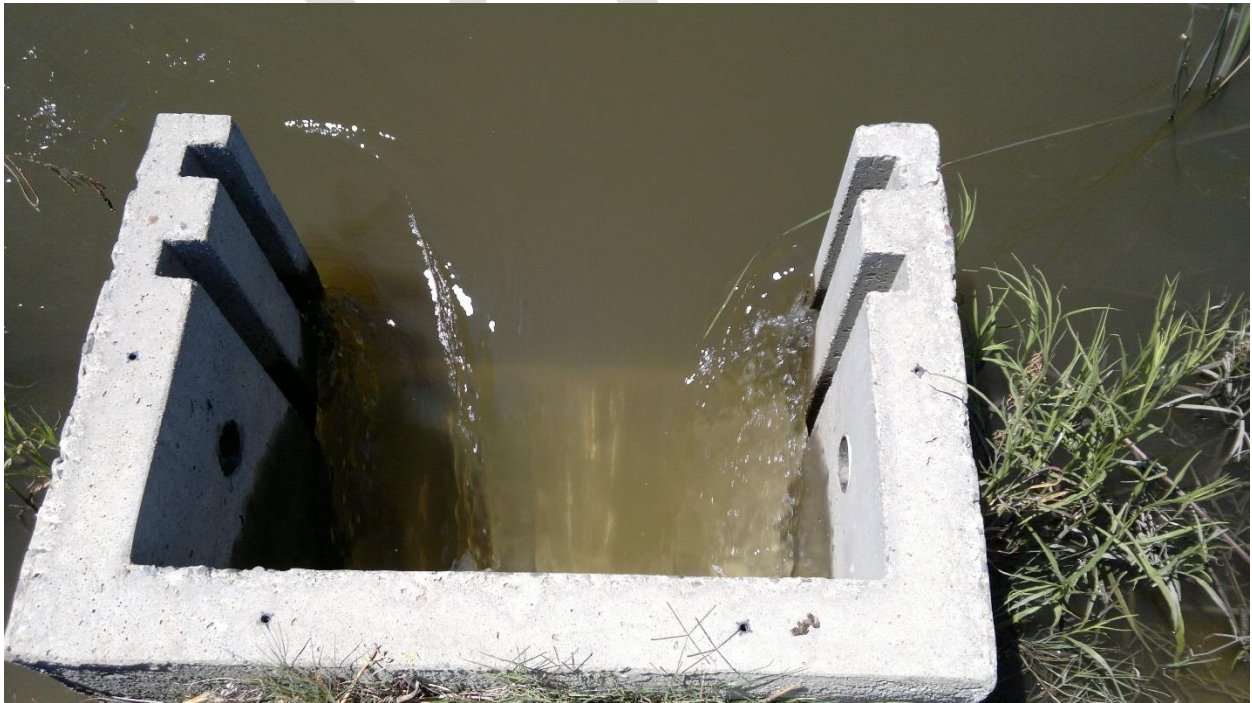
Photo 4. Weir on Unnamed Tributary, upstream of effluent discharge – June 28, 2012

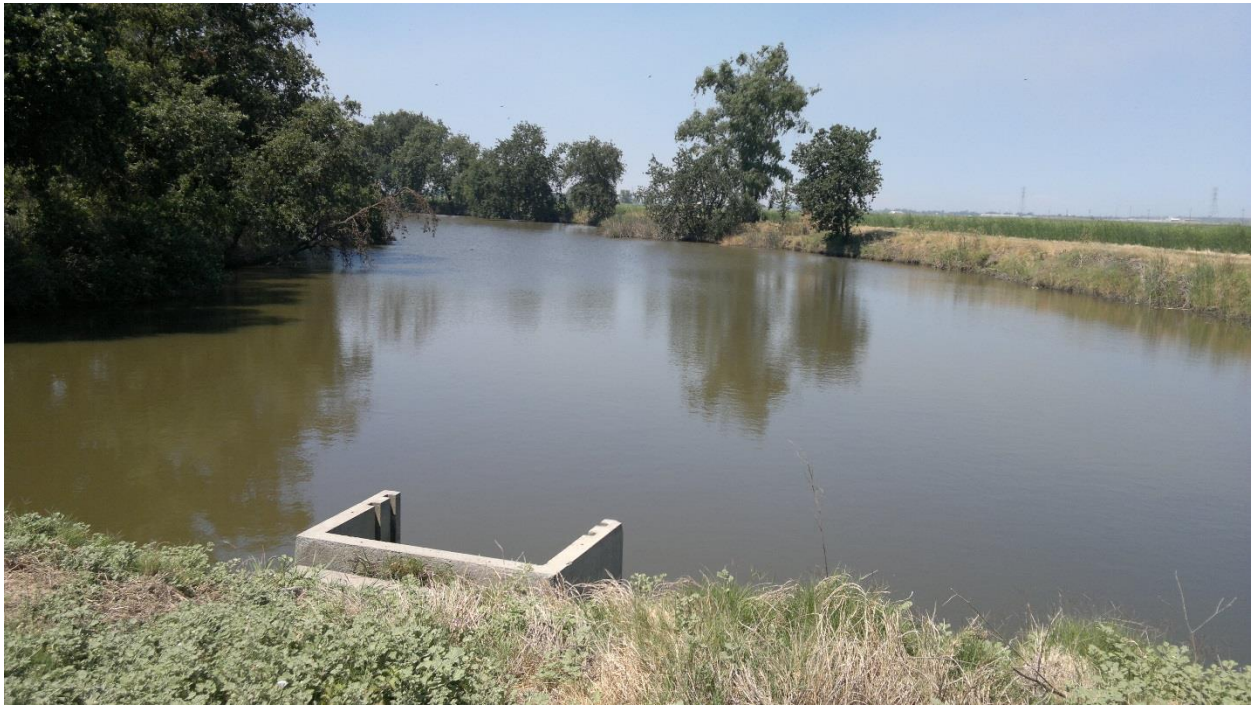
Photo 5. Weir on Powell Slough, upstream of Unnamed Tributary confluence (looking upstream) – June 28, 2012

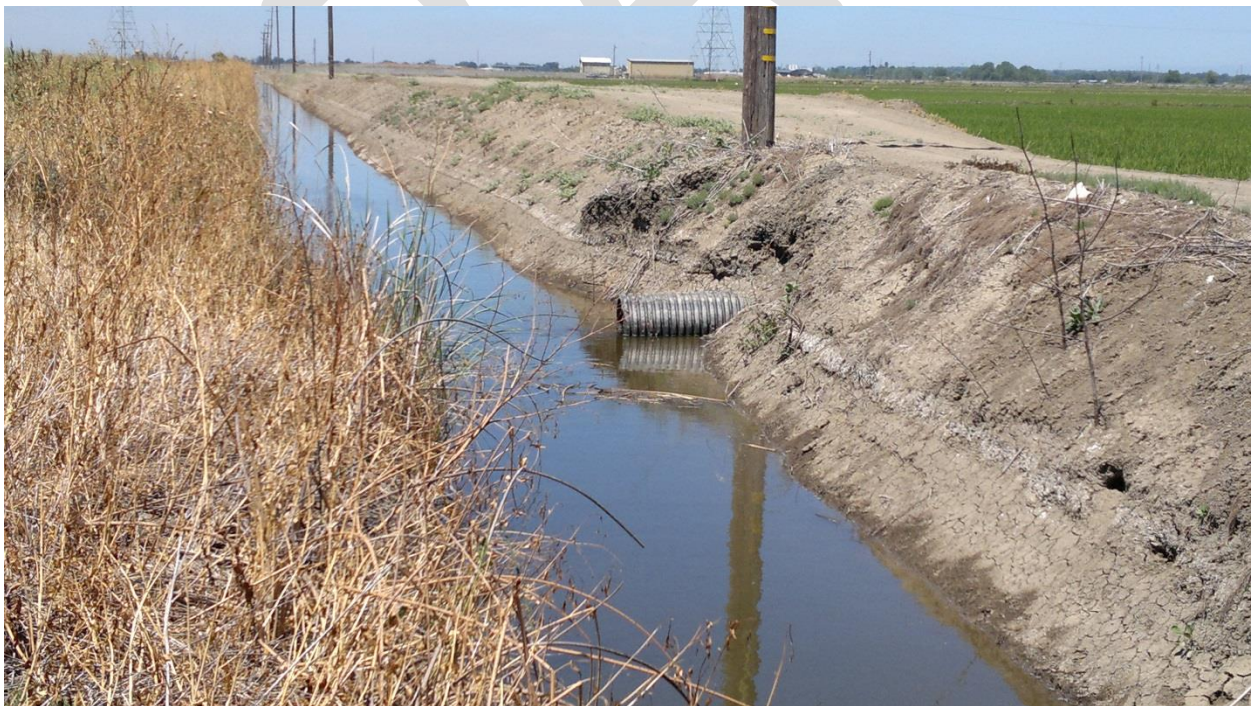
Photo 6. Field spill pipe from adjacent rice field to Unnamed Tributary (looking upstream) – June 28, 2012

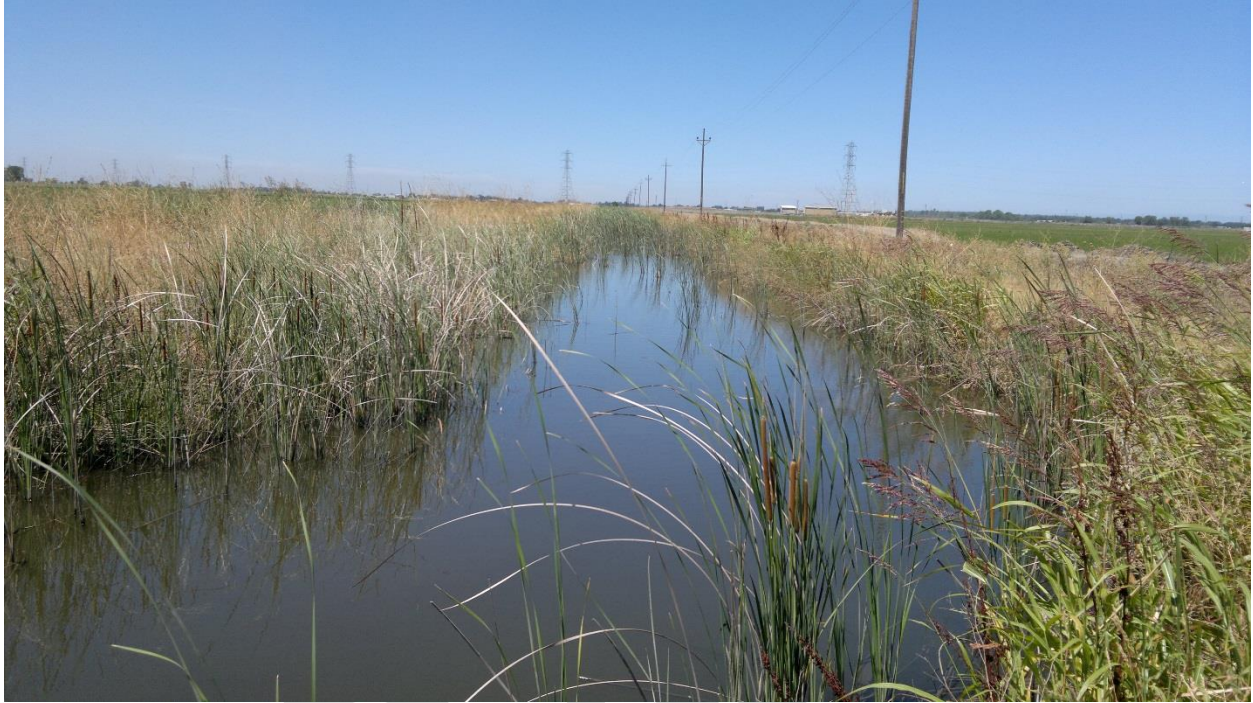
Photo 1. High Flow Period during irrigation season, Unnamed Tributary upstream of effluent discharge (looking upstream) –June 28, 2012

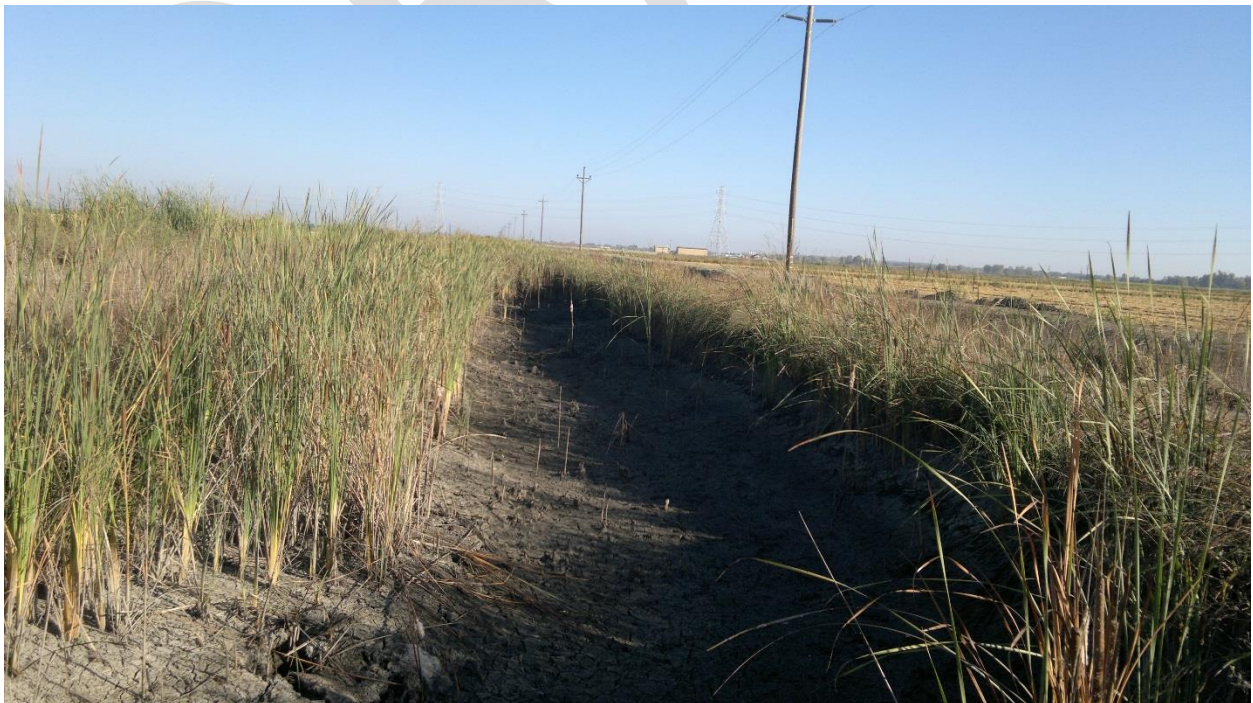
Photo 2. Low Flow Period after irrigation season, Unnamed Tributary upstream of effluent discharge (looking upstream) –October 9, 2012

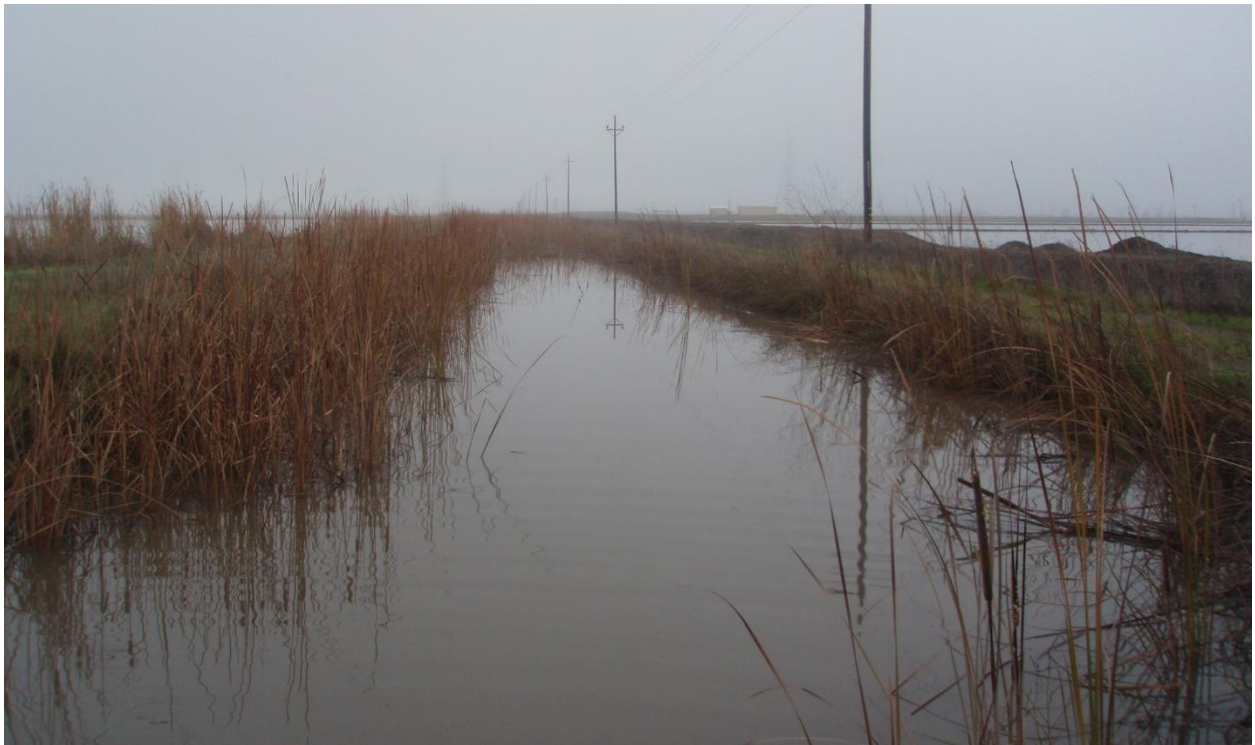
Photo 3. High Flow Period during storm season, Unnamed Tributary upstream of effluent discharge (looking upstream) –December 26, 2012

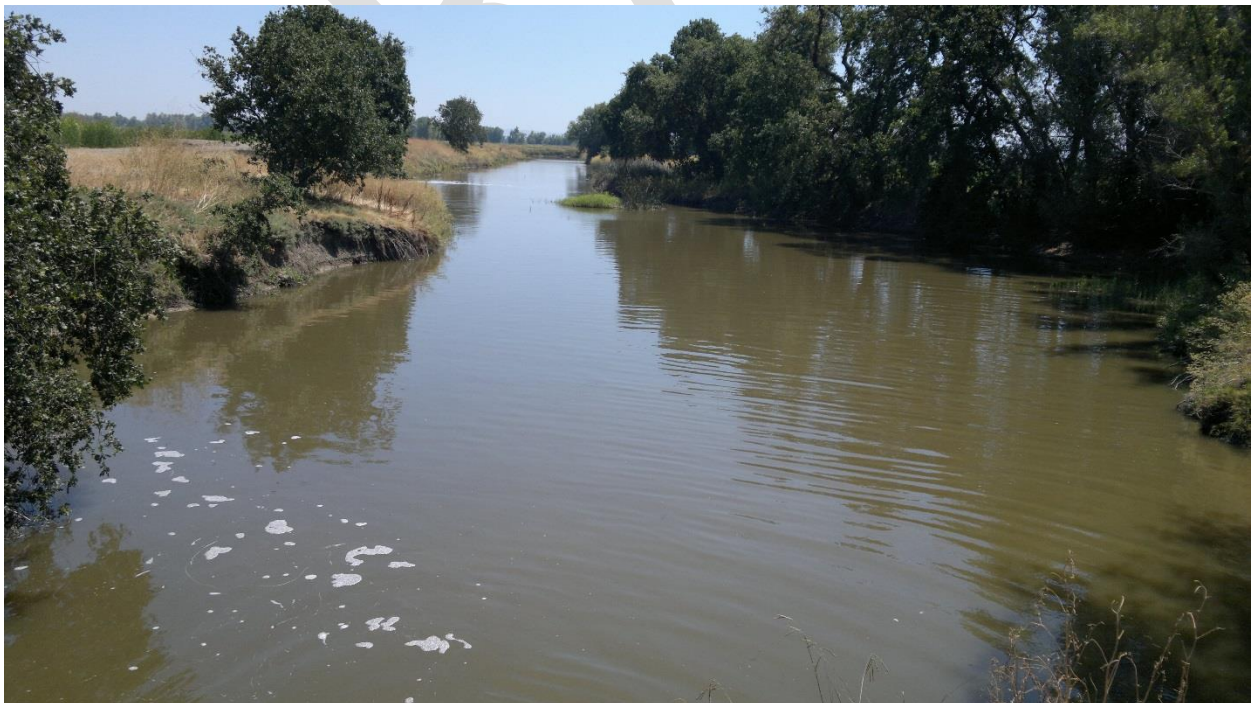
Photo 4. High Flow Period during irrigation season, Powell Slough, upstream of Unnamed Tributary confluence (looking downstream) – June 28, 2012

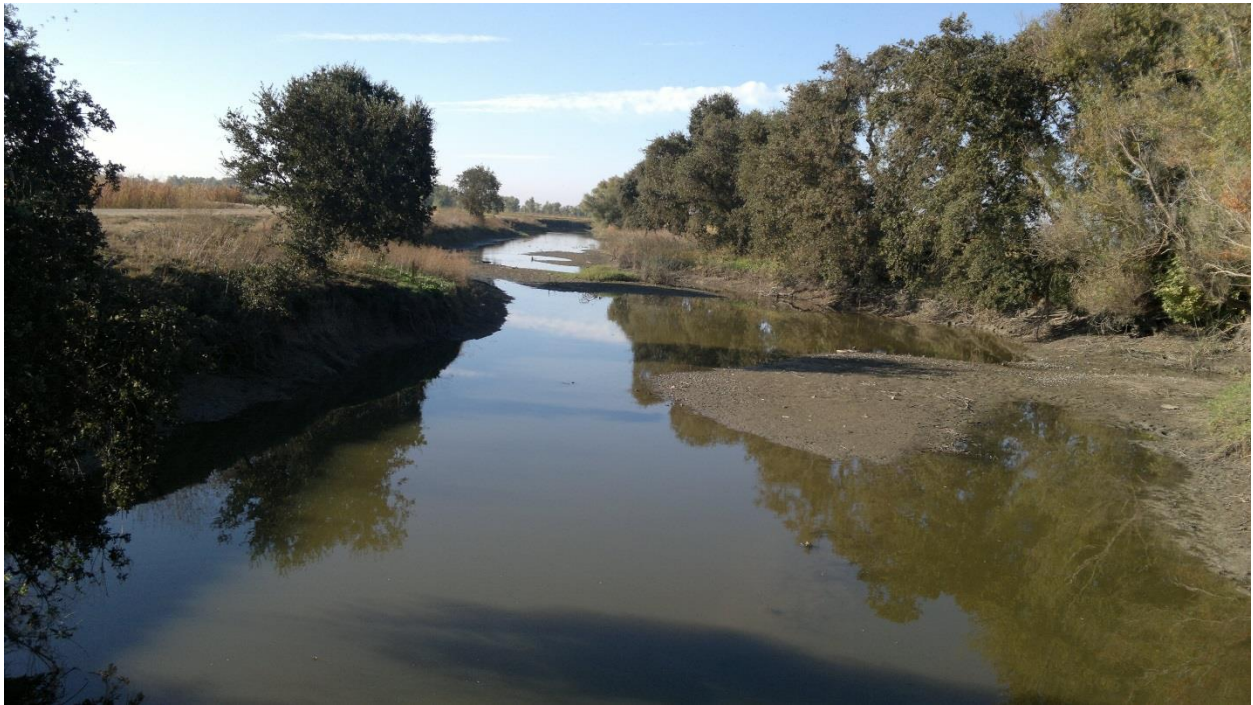
Photo 5. Low Flow Period, Powell Slough, upstream of Unnamed Tributary confluence (looking downstream) – October 9, 2012

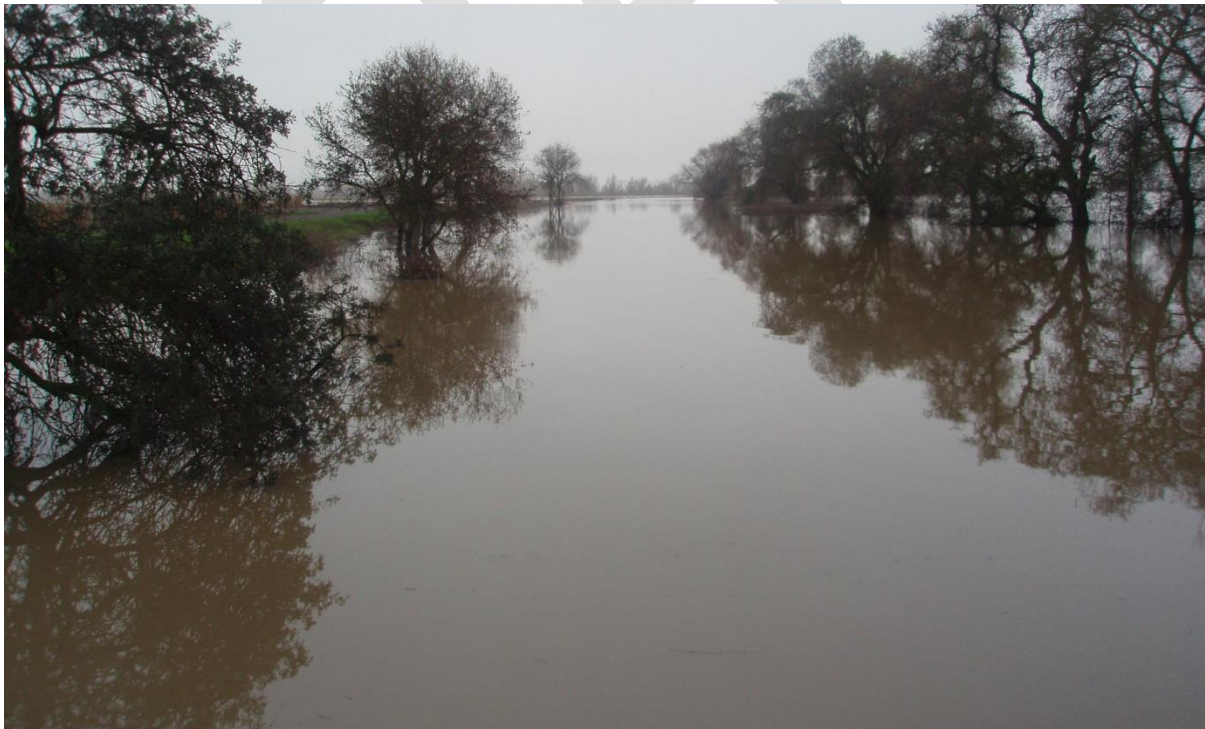
Photo 6. High Flow Period during storm season, Powell Slough, upstream of Unnamed Tributary confluence (looking downstream) – December 26, 2012
